Case Study

BiOWiSH™ Manure and Odor - Beef & Dairy

Manure Lagoon Treatment at Leppington Pastoral Co., Australia

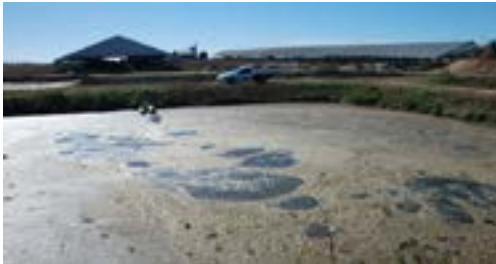
The primary pond receiving newly streamed effluent

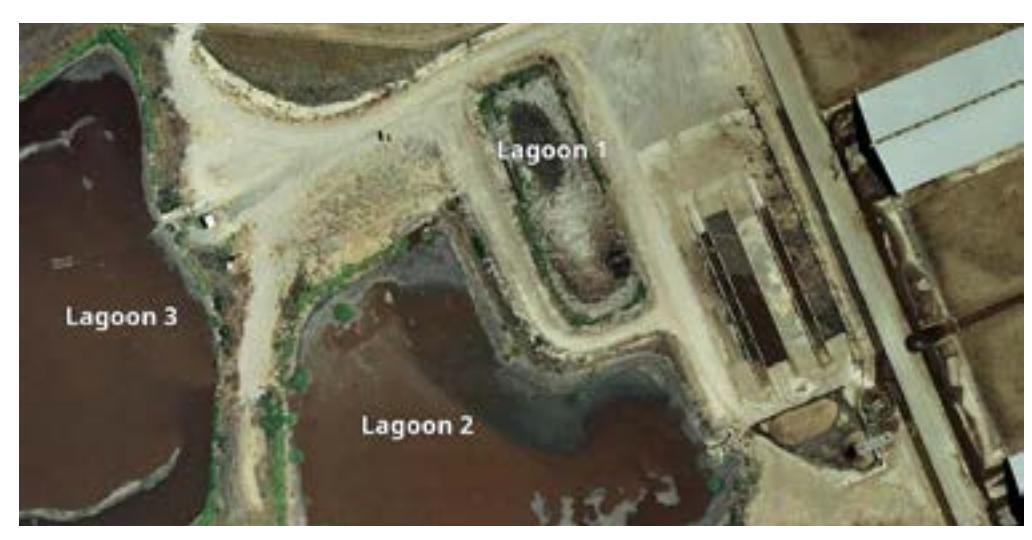
Satellite image of manure lagoon system with visible crust formation on the surface of Lagoon 1

The formation of crust on the manure lagoon surface had been a persistent problem for farm management. The crust creates a sealing effect which prevents natural aeration and contributes to an unbalanced anaerobic state in the manure lagoon. Crusting also intensifies odors and creates a breeding ground for flies and ultimately disease. For the lagoon system to work efficiently, the crust had to be removed mechanically on a regular basis.

Before the start of the project, severe crusting on the pond surface had required regular mechanical excavation, costing a lot of time and money for the farm owners. Since the adoption of BiOWiSH™ the effluent pond has now been totally free of crust even when solids screening is not in operation. The removal of the crust also led to a noticeable reduction in odor within the farm.

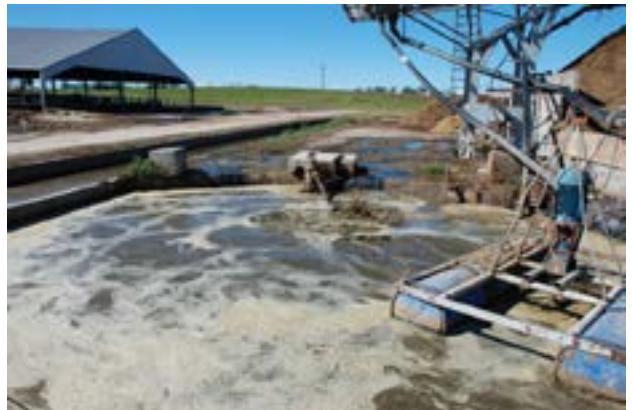
Solids screening in progress

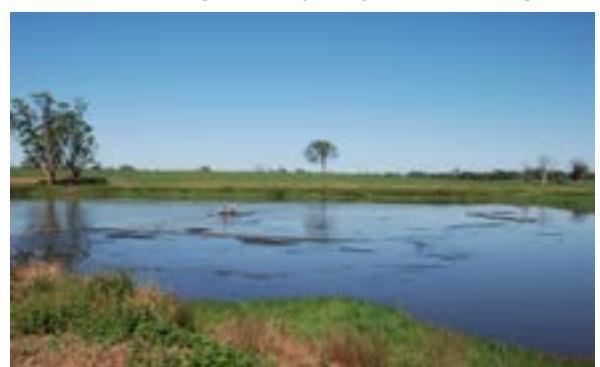
The tertiary storage pond is used for washing feed pads and irrigation

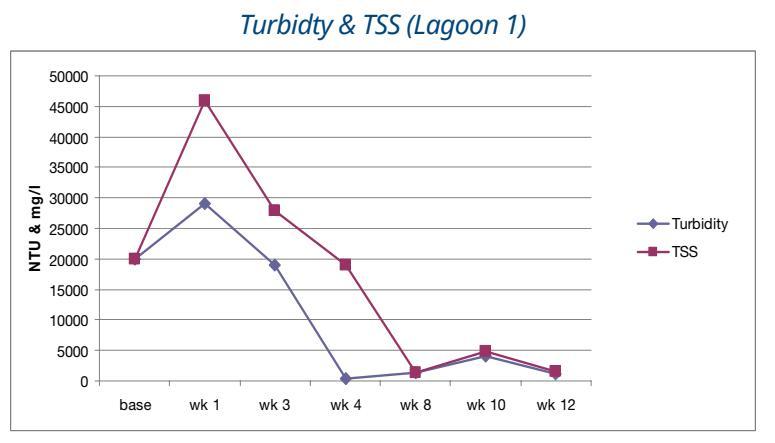
Shortly after the adoption of BiOWiSH[™], small bubbles of gas were visible from the pond surface and an initial spike in turbidity and total suspended solids (TSS) was recorded. This is typical of the new BiOWiSH[™] biology that rapidly oxidizes organic waste, reactivating organic sludge sitting at the bottom of the pond and bringing it back into suspension.

By the end of week 12, turbidity and TSS in the primary effluent pond had been drastically cut by 94% and 92%, respectively.

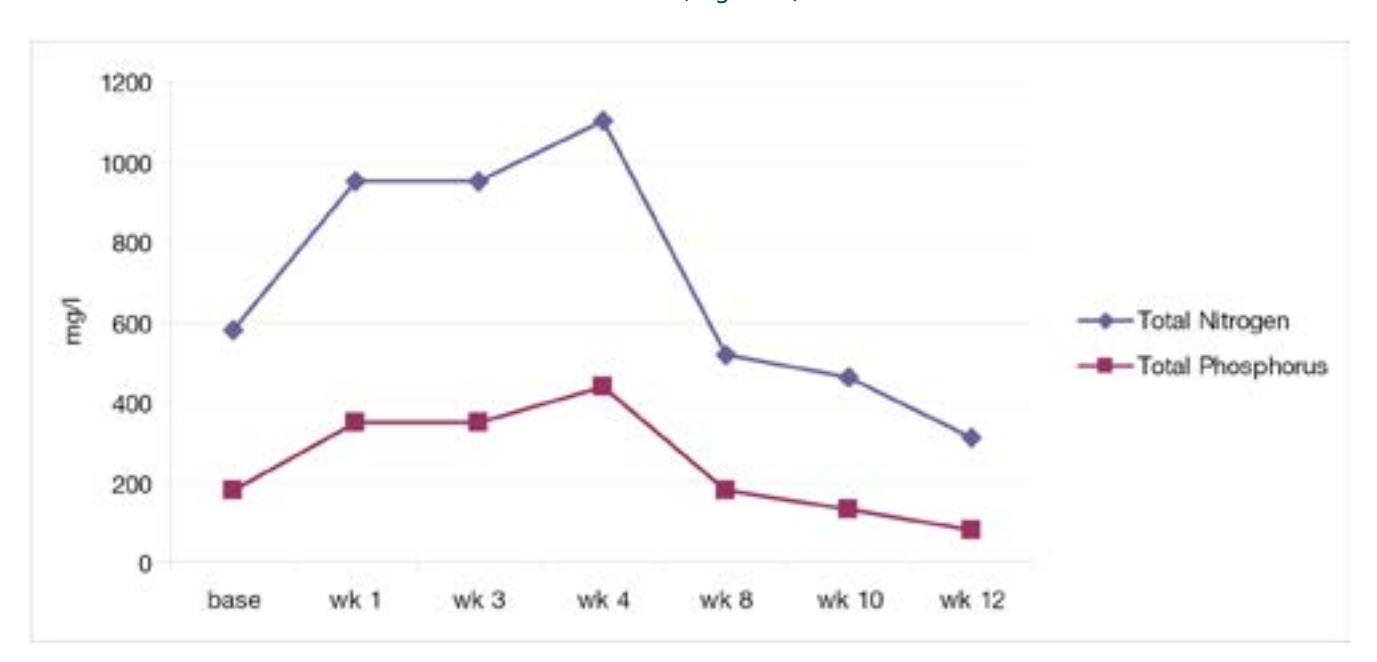
TKN & TP (Lagoon 2)

The new BiOWiSH[™] biology had also accelerated the removal of nutrients in all three lagoons on site. Testing conducted on the secondary and tertiary lagoons used to recycle water for irrigation had revealed significantly lower nutrient levels by end of week 12. Total Nitrogen (TKN) in the secondary and tertiary lagoons had dropped by up to 47%, whilst Total Phosphorus (TP) had dropped by up to 54%.
